REPORT ON THE OSMAG-KPA-TKP MARINE OIL SPILL EMERGENCY RESPONSE TRAINING & TIER II DRILL CONDUCTED IN NOV 2019

Tuesday 26th – Friday 29th November 2019

Prepared by Francis SAHA Environment Manager

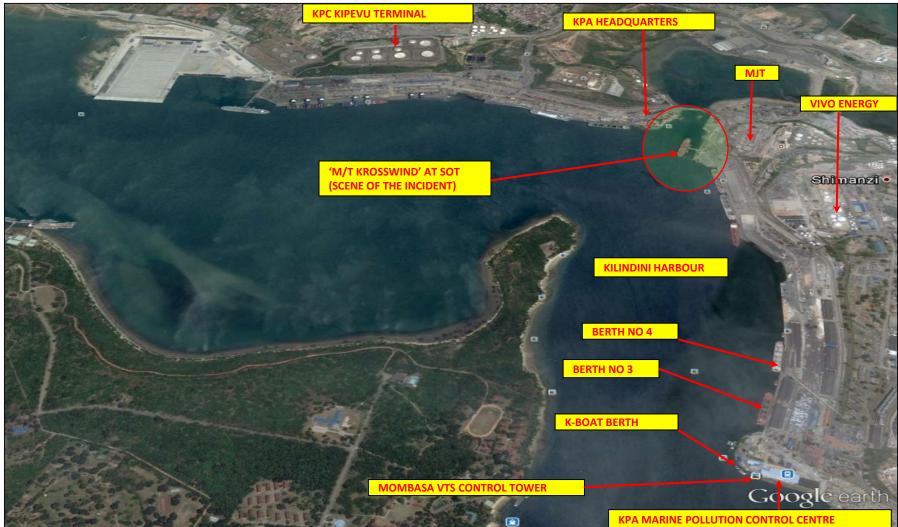
OSMAG/KPA/TKP MARINE EMERGENCY RESPONSE TRAINING & TIER II DRILL – – 26TH – 29TH NOV 2019 Location of the Incident Scene (S.O.T), Marine Pollution Control Centre & Mombasa VTS Control Tower

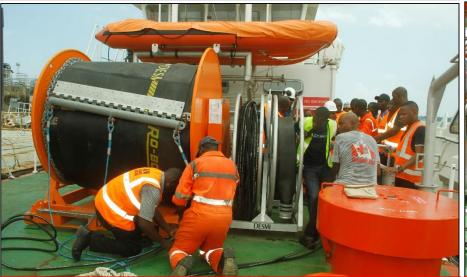
KPA MPCC Staff prepare the boom for deployment demonstration

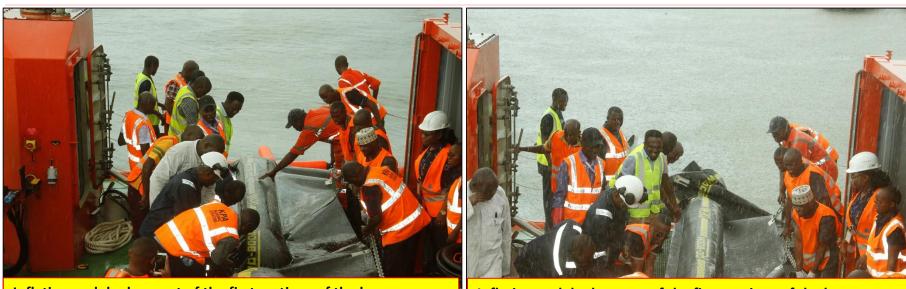
Inflation and deployment of the first sections of the boom

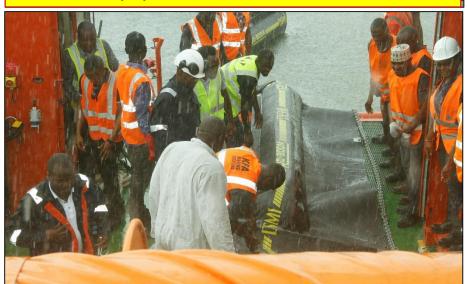
Inflation and deployment of the first sections of the boom

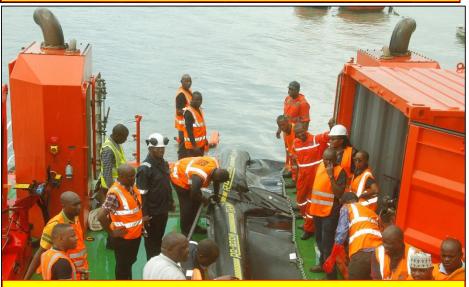
Deflation and retrieval of the boom after the practical demo

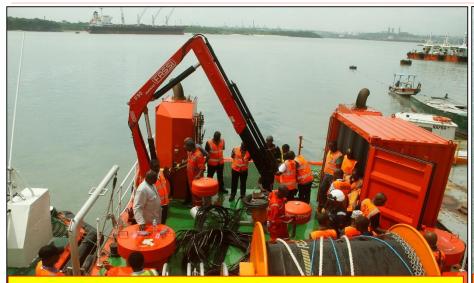
KPA-MPCC Staff secure the skimmer onto an onboard crane unit

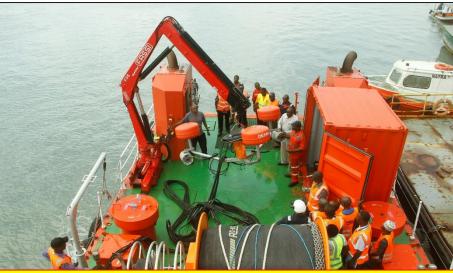
Lifting of the skimmer for deployment via the onboard crane unit

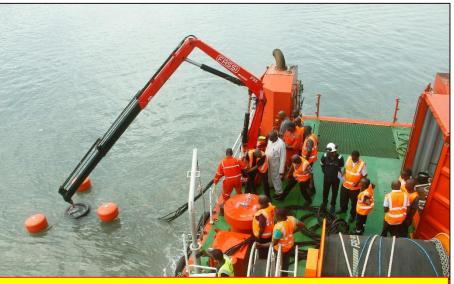
Deployment of the skimmer into the water

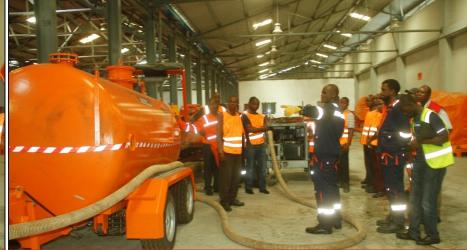
Engr Okanga explains the functionality of a recovered oil storage tank and its connections to the vacuum recovery unit

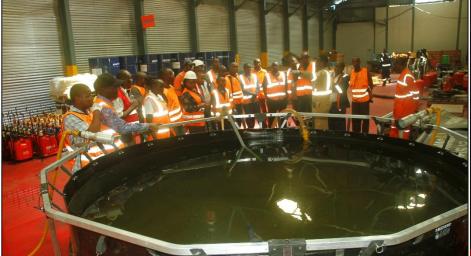
Mr Gitau explains to delegates the functionality of fully assembled and charged FastTank unit

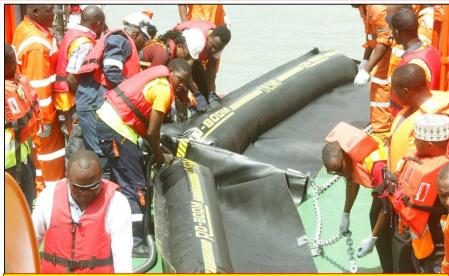
B&S Team proceed with inflation and deployment of the boom

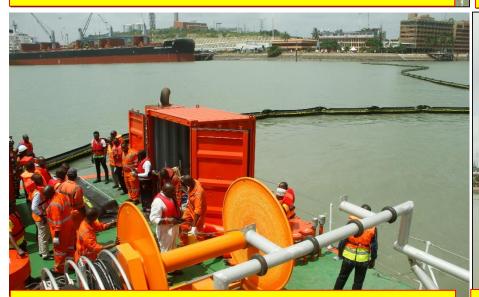
B&S Team complete roll out of the entire boom from its reel

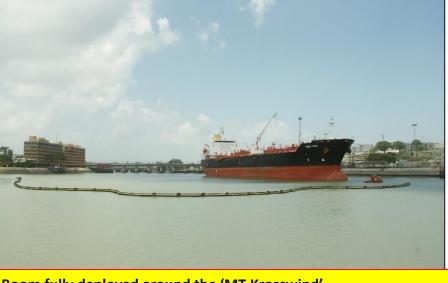
Boom fully deployed around the 'MT Krosswind'

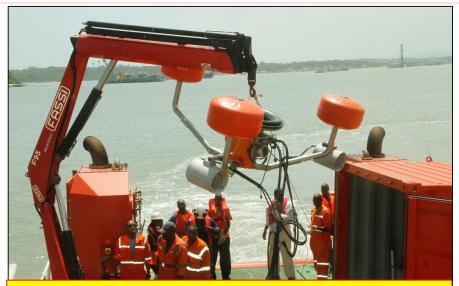
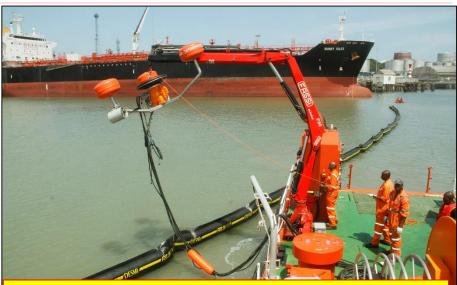
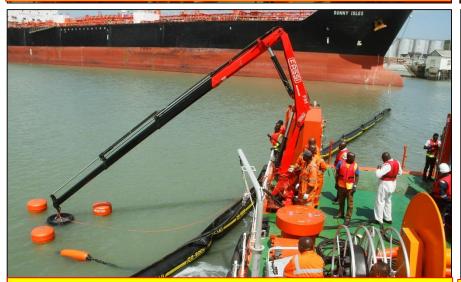
B&S Team deploying skimmer into the water

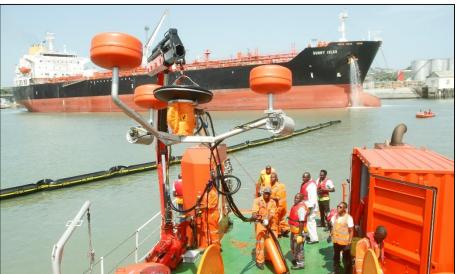
Retrieval of skimmer after completion of the skimming exercise

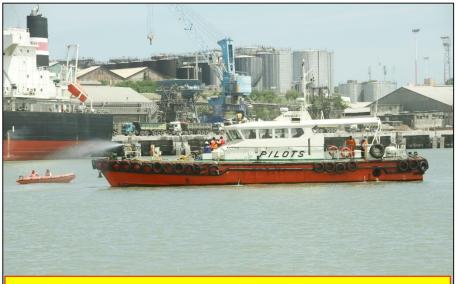
Dispersants Team guided by OSC in dingy boat spray dispersants

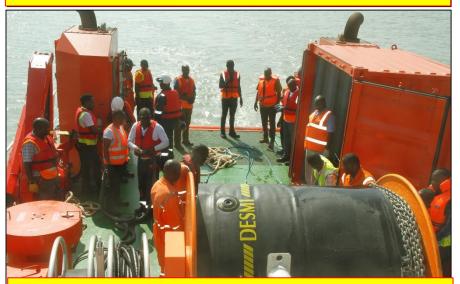
Boom fully recovered from the water and back on its reel

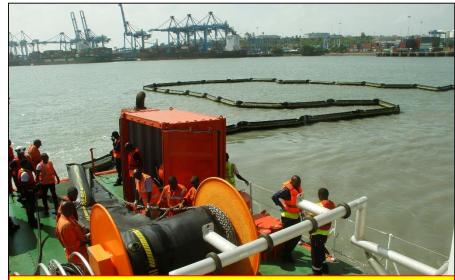
Retrieval of the boom in process
